# APPLIED APPROACH SLAB SETTLEMENT RESEARCH, DESIGN/CONSTRUCTION

FINAL REPORT ~ FHWA-OK-13-09  
ODOT SP&R ITEM NUMBER 2227

Gerald A. Miller, Kianoosh Hatami, Amy B. Cerato, Colin Osborne  
School of Civil Engineering and Environmental Science  
University of Oklahoma

August 2013

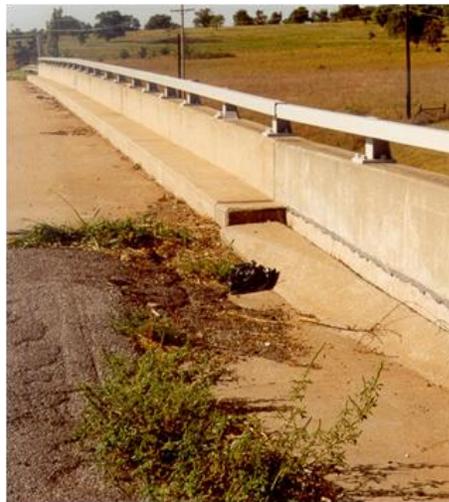
In older bridges it was not uncommon to see approach slabs without a mechanical connection to the bridge, which resulted in an abrupt displacement (bump) at the approach slab-bridge interface (joint) as depicted in Figure 1.1.

**Figure 1.1 Displacement at Bridge Approach Slab-Bridge Interface due to Differential Settlement**

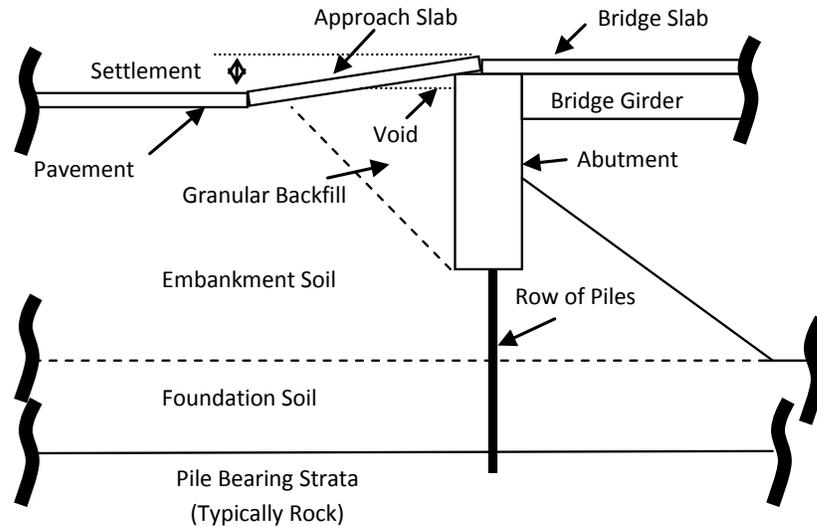
**Figure 1.2 Schematic Cut-Away Cross-Section View of Possible Consequence of Approach Slab Settlement Accompanied by Void Formation, Based on Integral Abutment Bridge (Not to Scale)**

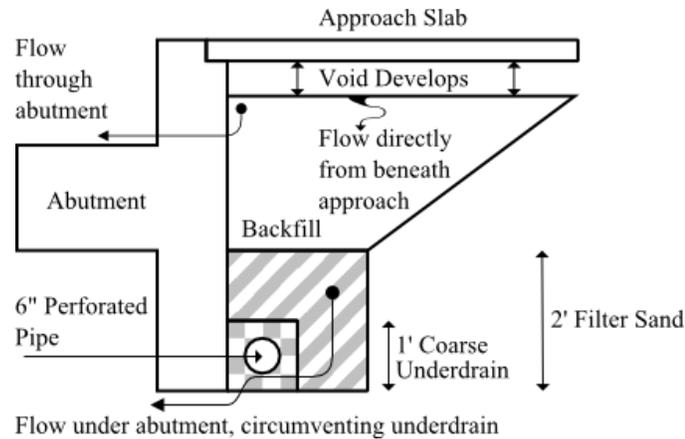
the abutment, laterally from directly beneath the approach slab, and through cracks and joints in the abutment. Many sites use rip-rap or concrete slope walls obscuring visual observation of the abutment; in some cases, definitive comments about erosion cannot be made. The common flow paths are illustrated in Figure 4.1 using a typical abutment design.

**Figure 4.1 Diagram of Most Significant Erosion Paths**

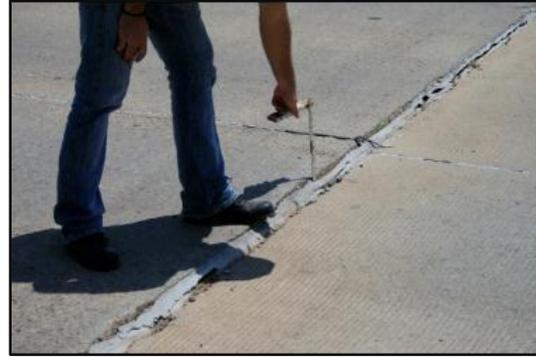
Examples of common problems are seen in Figure 4.4. A large gap can be seen between the wing wall, moving outwards, and the approach slab on Tecumseh Road over I-35. The developing bump on S.H. 6 over West Elk Creek has pulled the seal between pavement slabs apart. A concrete surface channel designed to carry water away from the embankment on S.H. 11 over I-35 failed and collapsed into a 3’ deep void beneath the channel.

**(b) Vertical separation destroys seal**

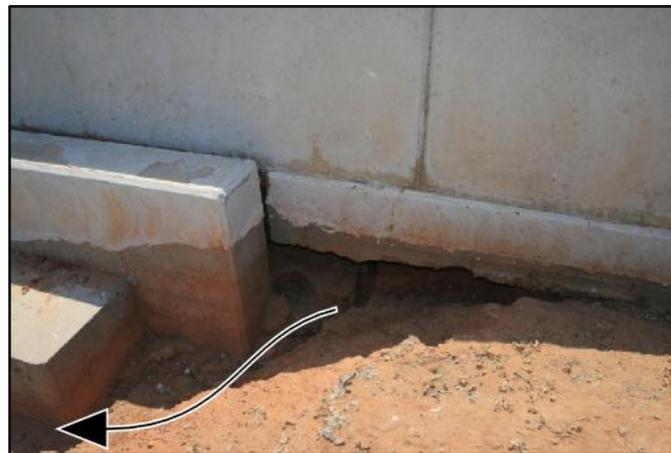
Once voids were present under the approach slab, soil was able to flow laterally directly from beneath the approach slab, as seen at S.H. 6 over Sadler Creek in Figure 4.7. An example of a void under the approach slab is shown at S.H. 59 A over Big Creek in Figure 4.8. An example of an under-abutment void is shown at U.S. 177 over Salt Fork, Bridge B in Figure 4.9.

**Figure 4.7 Soil flowing laterally from beneath approach slab**

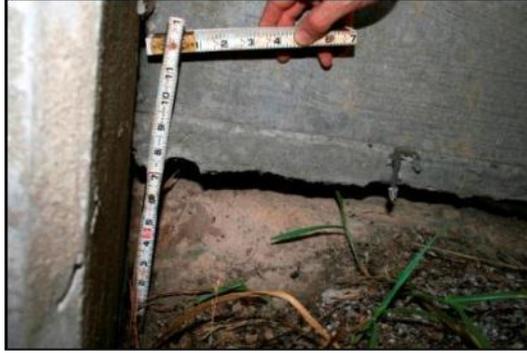
**Figure 4.8 A 7" void under approach slab**

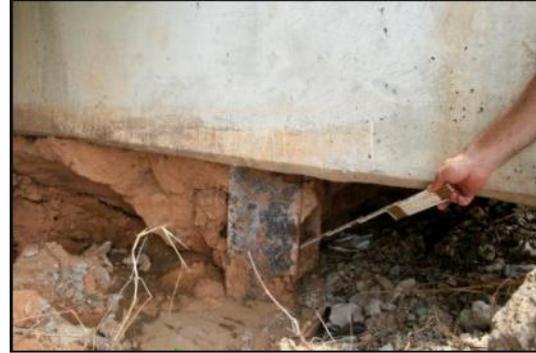
**Figure 4.9 A 1' 9" void under abutment**

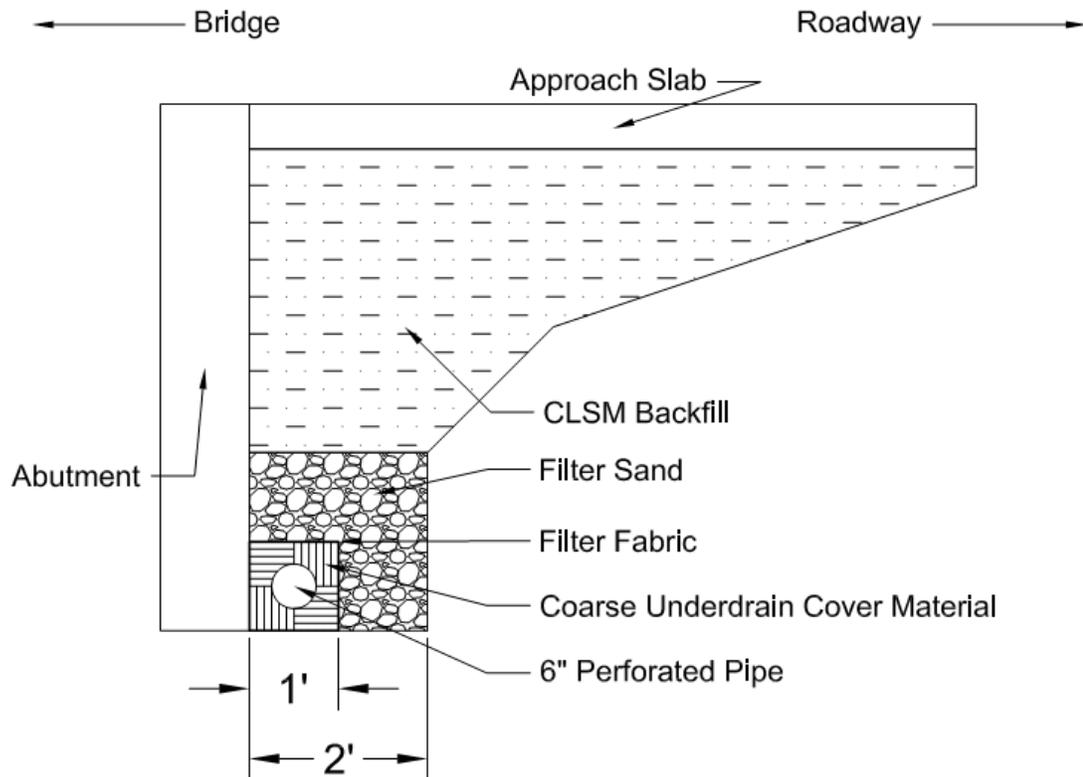
A variety of underdrain designs were observed for each of the 30 bridges investigated during the Level I site visits, with varying results. The standard ODOT underdrain design is specified for integral abutment bridges in sheets B40-I-ABUT-MISC 01E (2009) and 00E (1999), *Substructure Excavation and Pipe Underdrain Assembly Details Integral* and for conventional abutment bridges in sheets B40-C-ABUT MISC 01E (2009) and 00E (1999), *Substructure Excavation and Pipe Underdrain Details Conventional*. Of the bridges identified in this section, none uses the standard exactly; instead, many are similar but modified while others vary significantly from the standard. The major change between 1999 and 2009 is the addition of “filter fabric” being wrapped around the 1' coarse cover material. A concern with the standard design is that there is no mechanism to prevent water from flowing under the abutment and transporting soil material. The standard underdrain design is illustrated in Figure 4.10.

**Figure 4.10 Standard ODOT underdrain design, after ODOT 2009 Integral Bridge Design Standards & Specifications**

properly. Four alternatives to the design shown in Figure 4.10 are presented in Figures 4.38 to Figure 4.41. The essential element in these figures is the water stop, in the form of a geomembrane, that prevents water from escaping under the abutment. Figures 4.40 and 4.41 place the drain below the bottom of the abutment for added insurance that water will preferentially flow into the drain. Other differences noted in the figures are the use of a granular filter material (Figures 4.38 and 4.40) versus a geotextile filter (Figures 4.39 and 4.41) to protect the coarse cover material surrounding the drain pipe. The geomembrane ideally should exhibit high elongation under load, such as found with high density polyethylene or PVC to accommodate stretching forces that may occur as the drain settles relative to the abutment. That is, friction between the geomembrane and concrete may resist the downward movement of the geomembrane if the soil underlying the drain settles. A geomembrane with high elongation potential should be able to accommodate this action. Furthermore, it would be desirable to minimize the friction between the geomembrane and concrete abutment to allow the geomembrane to simply slip downward if the underlying soil settles. Of course, the height of the geomembrane on the abutment side (i.e. the vertical overlap against the abutment) should be large enough to allow some downward movement of the drain relative to the abutment without compromising the water stop.

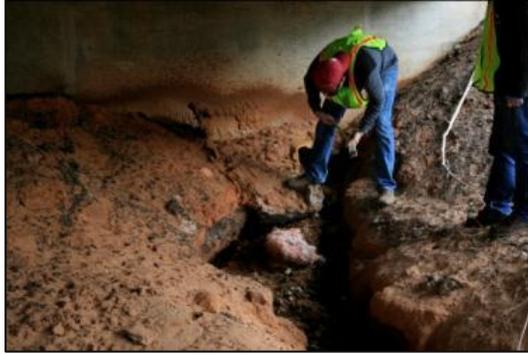
Erosion under the abutment was a common observation during Level I investigations. Four bridges in Caddo County, S.H. 152 over Lake Creek, S.H. 152 over Lake Creek Overflow, S.H. 152 over Willow Creek and S.H. 9 over Running Creek experienced this problem. No underdrain was specified at these locations. An erosion channel at S.H. 152 extending from beneath the abutment to Lake Creek is shown in Figure 4.11 and Figure 4.12.

**Figure 4.11 Erosion channel under abutment at S.H. 152 over Lake Creek**

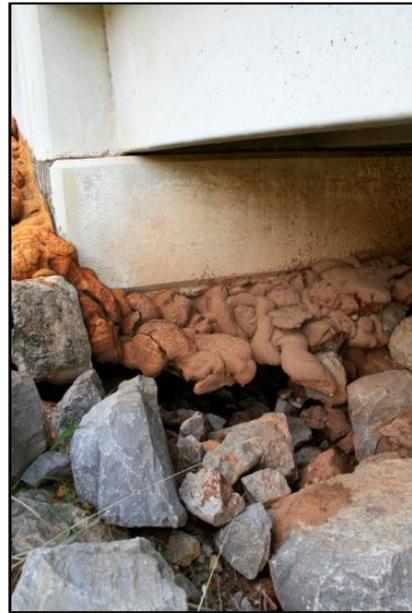
A similar channel was observed at S.H. 152 over Willow Creek and is shown in Figure 4.13. Expanding foam maintenance was used beneath S.H. 9 over Running Creek, but the erosion continued and a void is present even below the foam as seen in Figure 4.14. An example of erosion beneath the abutment is presented in Figure 4.15.

**Figure 4.14 Void and maintenance under abutment at S.H. 9 over Running Creek**

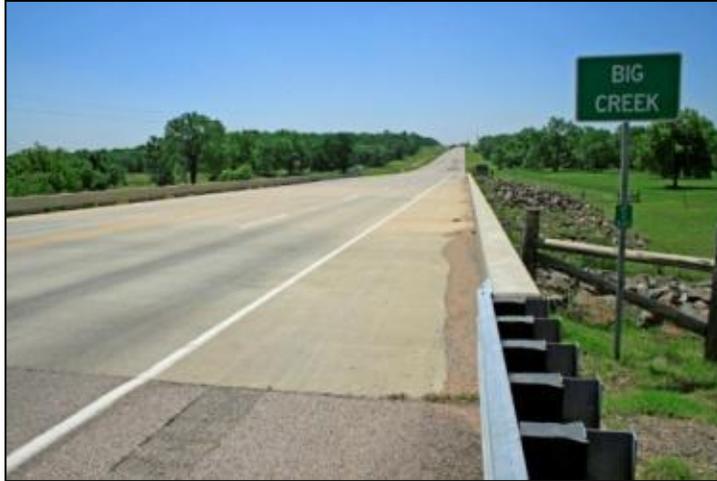
**Figure 4.16 The driving surface is smooth on S.H. 3W over Big Creek**

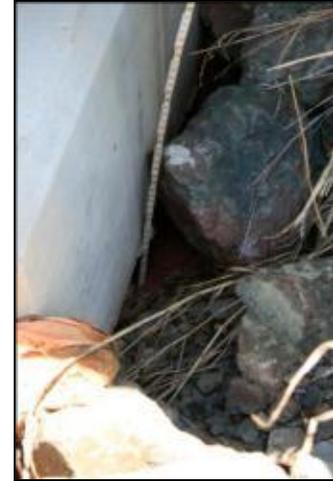
State Highway 3W over Big Creek is a conventional abutment bridge with an underdrain design fairly similar to the 1999 standard. The major difference is that, instead of having a filter sand layer and a coarse pipe underdrain material layer, there is only 2' of filter sand surrounding the pipe. Also, the top of the filter material is level with the bottom of the abutment. The approach performance at this site is acceptable. No bump was observed, and the surface structure was in good shape when the team visited on May 21<sup>st</sup>, 2011, as seen in Figure 4.16. There was however, a void developing under the abutment, as seen in Figure 4.17. The underdrain design for this site is shown in Figure 4.18.

**Figure 4.17 Void forming beneath abutment at S.H. 3W over Big Creek**

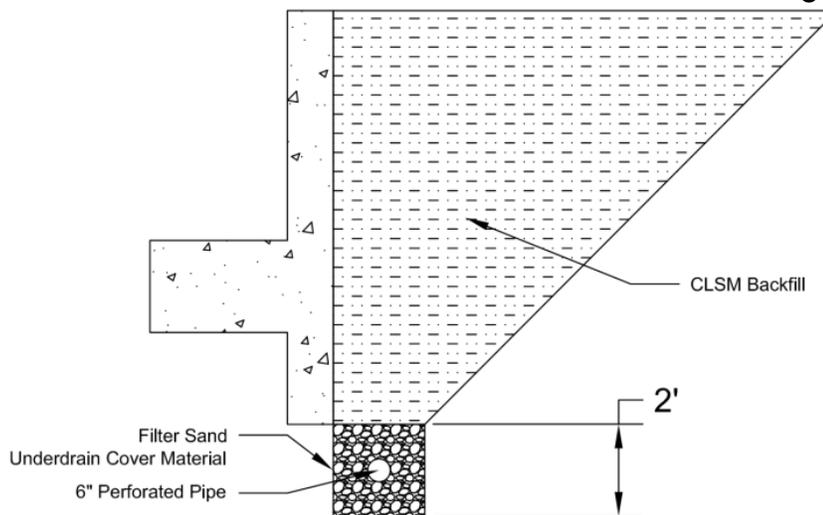
**Figure 4.18 Underdrain design, after ODOT Proposed Plan for S.H. 3W over Big Creek**

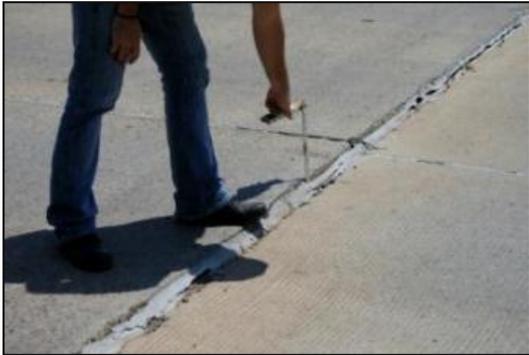
S.H. 6 over West Elk Creek features a design somewhat similar to the 1999 standard for integral bridges. The most significant difference is that granular backfill, as opposed to CLSM, is specified. The driving surface at this site is rough. A 3" bump was measured between the bridge and the north approach. Voids up to 4" were measured both under the approach slab and

**Figure 4.19 A 3" bump**

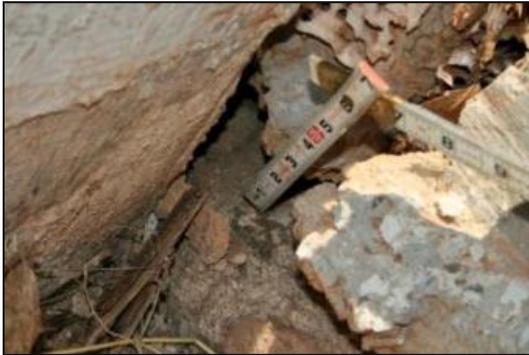
**Figure 4.21 4" void beneath the approach slab**

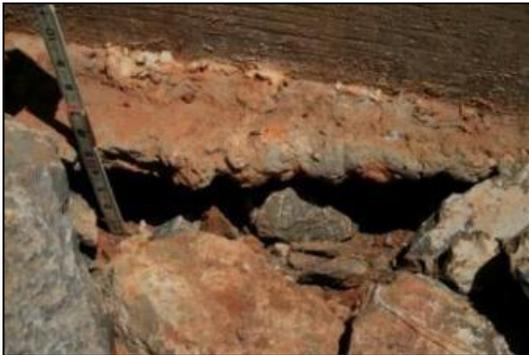
**Figure 4.20 4" void beneath the abutment**

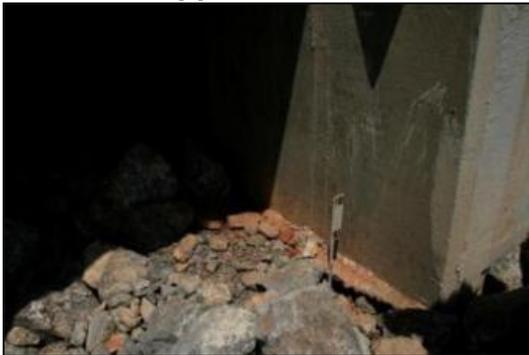
**4.22 Void beneath north abutment**

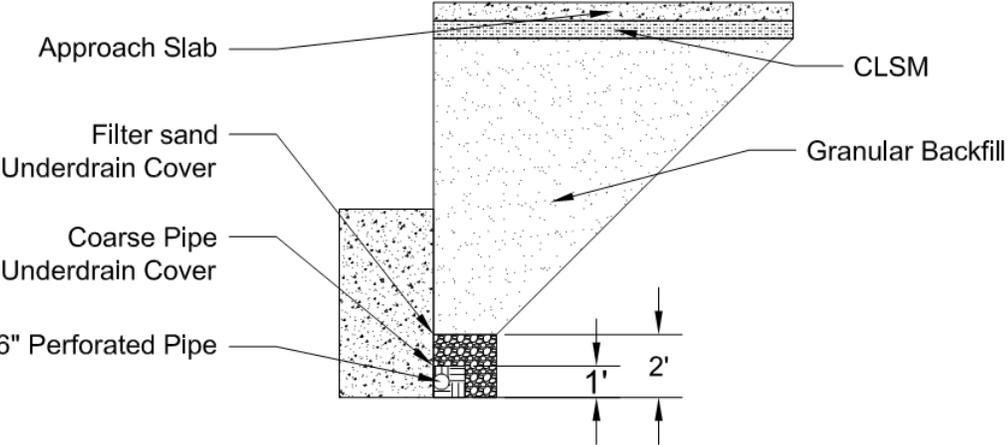
**Figure 4.23 Underdrain Design, after ODOT Proposed Plan for S.H. 6 over West Elk Creek**

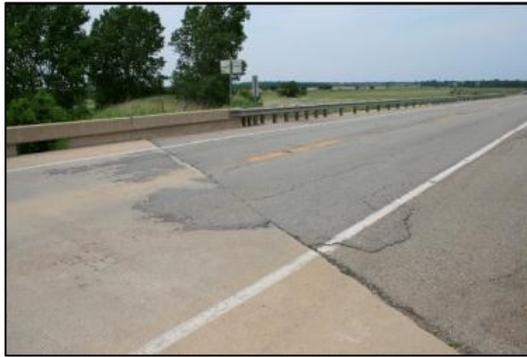
U.S. 177 over the Salt Fork consists of three bridges, each with different embankment construction techniques. Embankment A-2 was constructed using typical construction practices. A bump developed at this approach and the asphalt is cracked. Erosion was observed beneath the abutment. Figure 4.24 shows the approach A-2 and Figure 4.25 shows the observed erosion. The underdrain design is shown in Figure 4.26.

**Figure 4.24 US 177 Approach A-2**

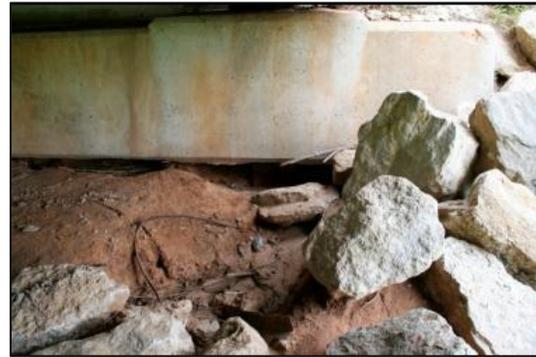
**Figure 4.25 Erosion under the abutment on US 177 Embankment A-2**

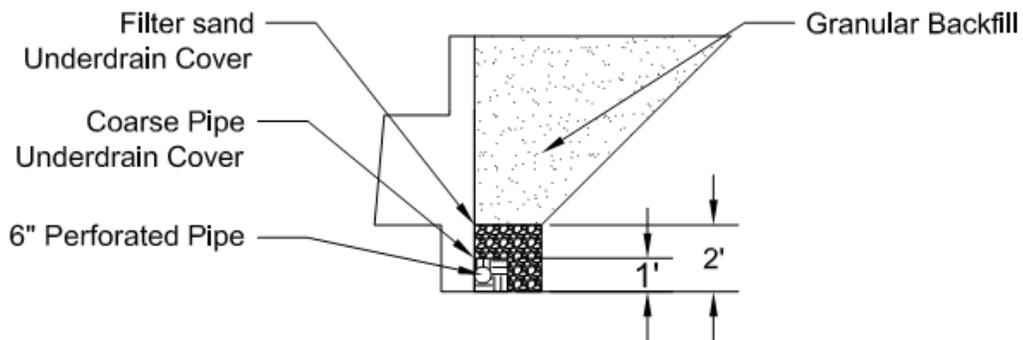
**Figure 4.26 Underdrain Design, after ODOT Proposed Plan US 177 over Salt Fork, Bridge A**

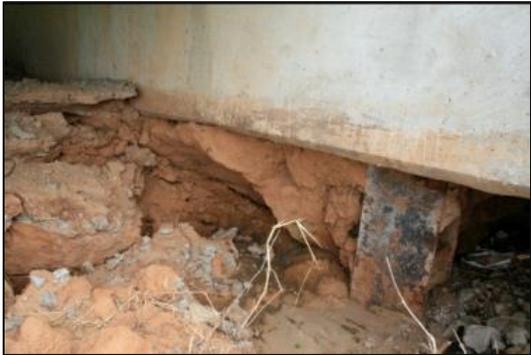
abutment was observed and is shown in Figure 4.28. The underdrain design is shown in Figure 4.29.

**Figure 4.28 Erosion beneath abutment at U.S. 177 over Salt Fork, Embankment B-2**

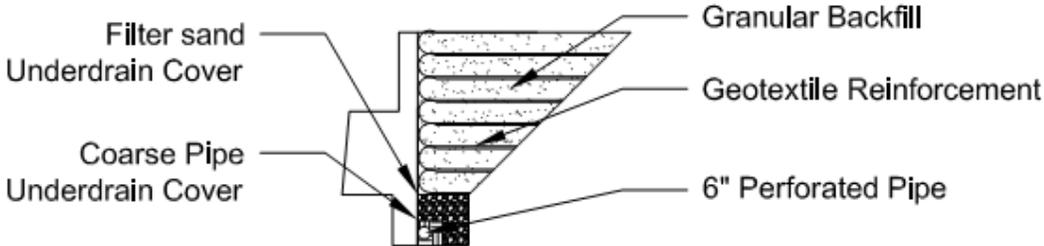
**Figure 4.29 Underdrain Design, After ODOT Proposed Plan U.S. 177 over Salt Fork**

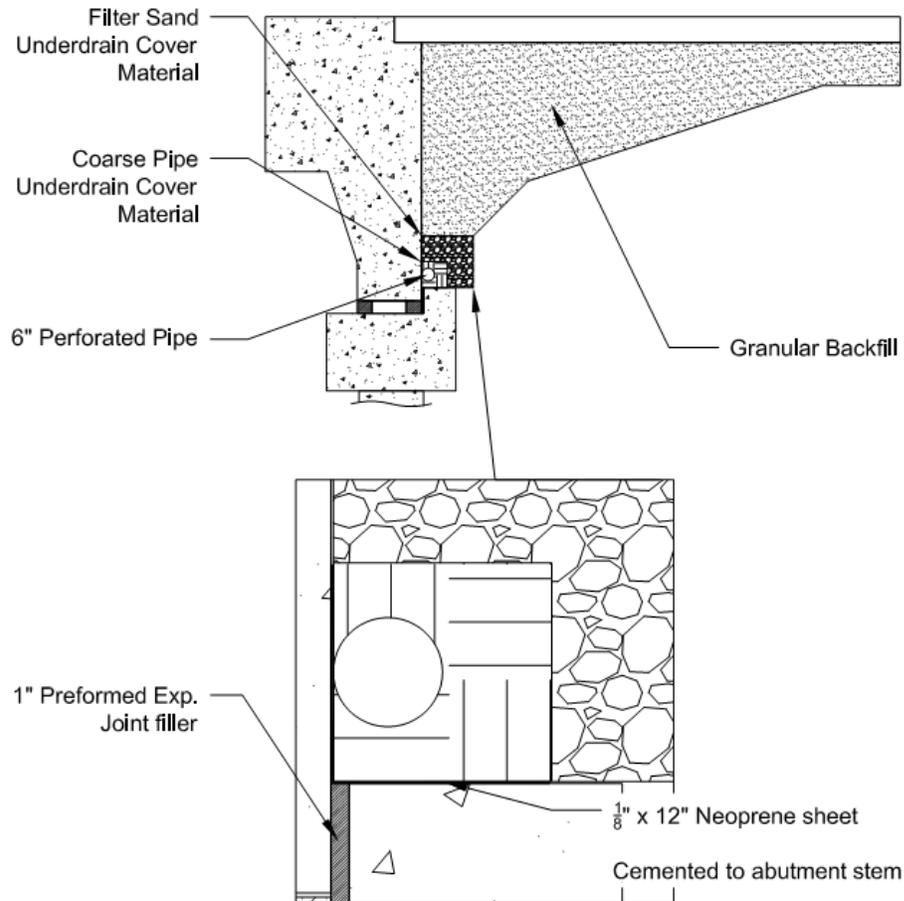
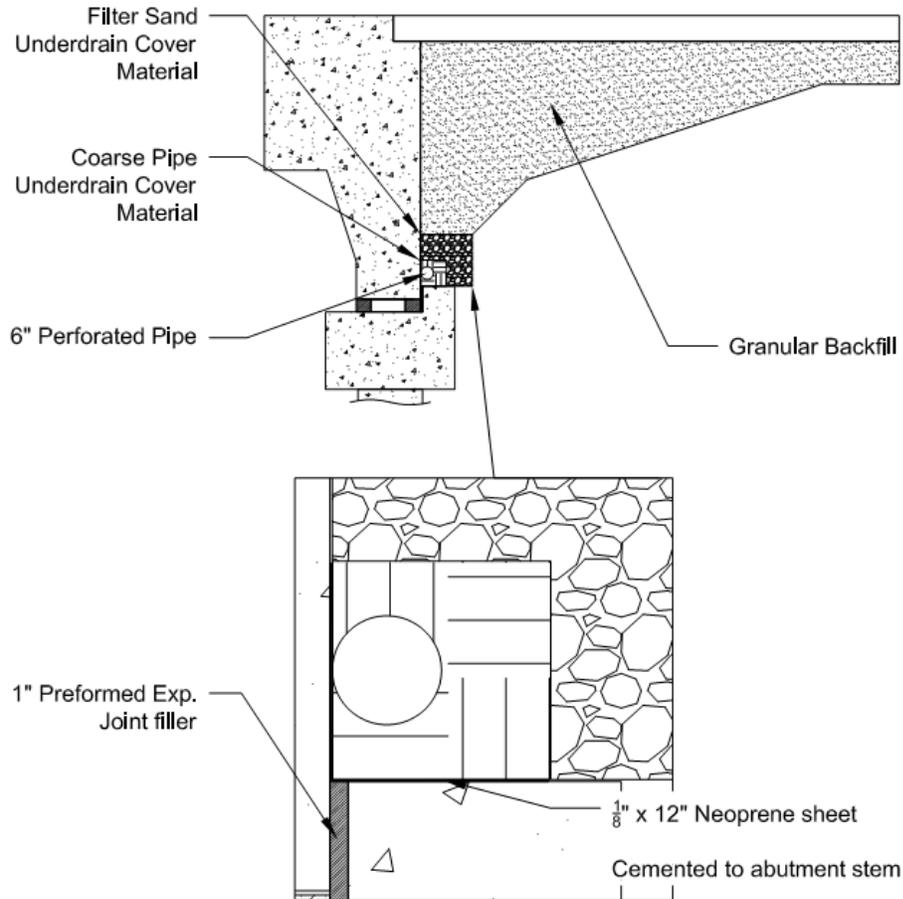
Shields Boulevard over I-35 utilizes an underdrain design that appears to prevent erosion beneath the abutment. A neoprene sheet is specified that prevents flow between the abutment and the abutment footing. The 6” perforated pipe is surrounded by coarse pipe underdrain material which is in

turn surrounded by filter sand; no filter fabric is specified. Granular backfill is specified. The underdrain design is shown in Figure 4.30.

**Figure 4.30 Underdrain Design, After ODOT Proposed Plan for Shields Boulevard over I-35**

A modification to this design is needed to introduce a water stop at the interface of the abutment and underlying soil. Figure 4.30 shows an example of a conventional abutment design where a water stop appears to have worked

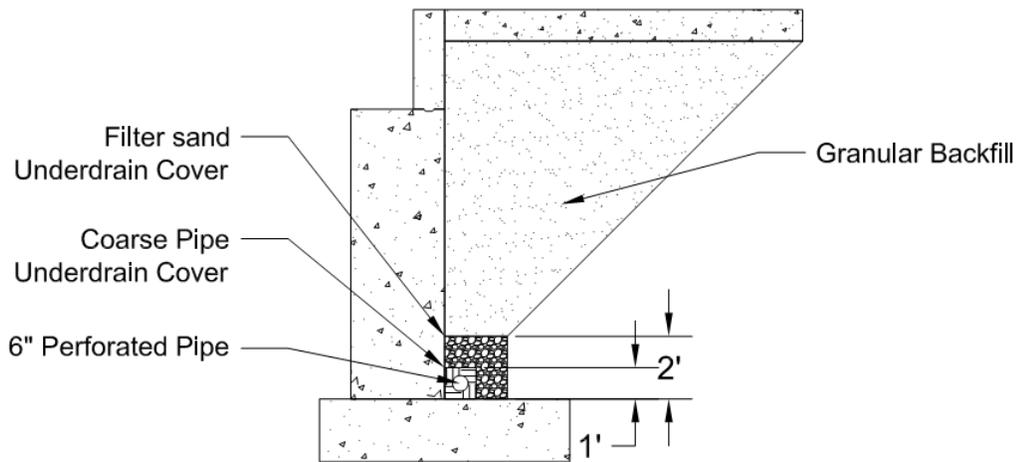
A concrete slab extends beneath the abutment and underdrain at Tecumseh Road over I-35. No erosion beneath the abutment has been observed at this site; however, asphalt had been poured into voids near the side of the abutment. There is possibility that water is flowing out of the side of the abutments. The general underdrain section is shown in Figure 4.31.

**Figure 4.31 Underdrain Design, After ODOT Proposed Plan for Tecumseh Road over I-35**

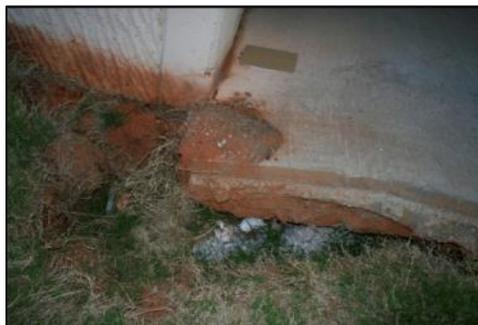
Another observed issue was soil being transported through drainage pipes. This indicates that improper filtering is allowing soil into the perforated pipes which are present in backfills and in slope walls. Shields Boulevard over I-35 provides an example of this. The pipes at this site are not only carrying water, but soil. Soil was observed to have flowed out of the outlets at this location, and voids were present at the abutment. This location has 8"-12" of settlement at the wing-walls, distress of the structure and approach slab, and a significant bump. The drainage outlet at the bottom of the slope wall is shown in Figure 4.32 and a developing void beneath the slope wall at the foot of the abutment is shown in Figure 4.33.

**Figure 4.33 Void forming beneath slope wall and abutment**

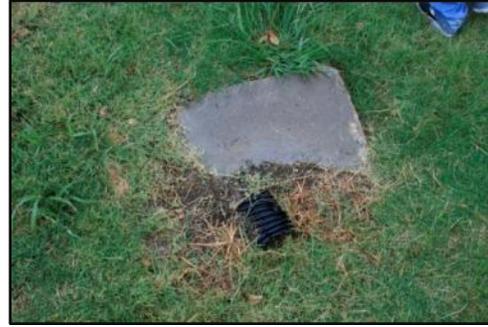
In many locations, the outlet drain is buried or crushed. The underdrain is useless if water cannot flow out of the outlet. Water becoming trapped in the embankment could have detrimental effects on the embankment performance. In Moore, bridges carrying 19<sup>th</sup> St. over I-35 and I-35 over Main Street have drains which are buried and blocked. No significant erosion was observed at either bridge, but the embankments were observed to have settled, as shown in Figure 4.36.

**(c) The outlet at I-35 over Main St. is almost completely buried**

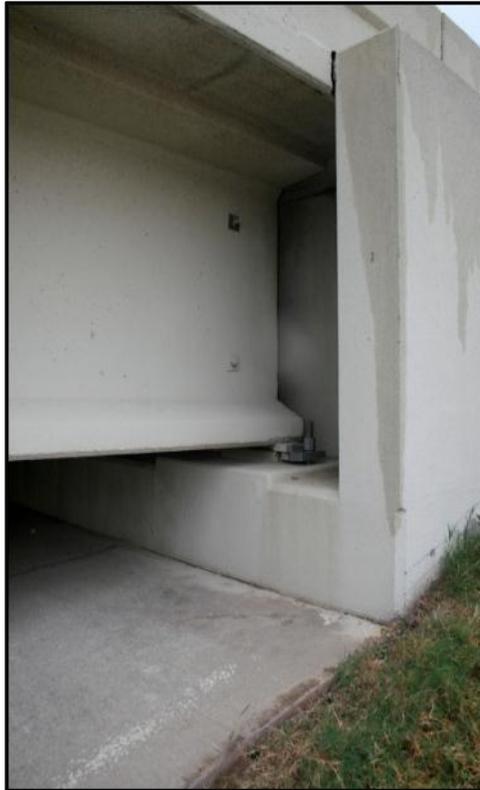
**(b) Blue lines on the wing-wall indicate the original soil level and the settlement of the embankment relative to the structure at 19<sup>th</sup> St. over I-35**

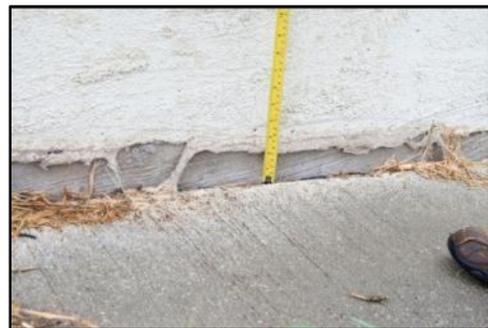
**(d) 2" of embankment settlement is measured between the embankment and wing-wall at I-35 over Main St.**

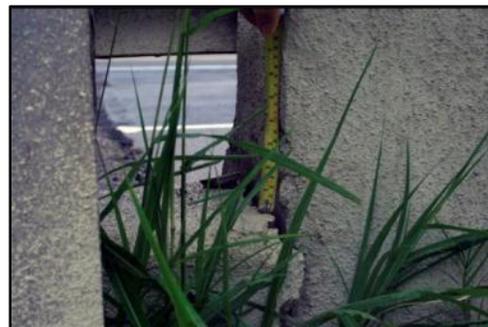
**(e) 2" vertical separation is measured between the pavement and bridge interface at I-35 over Main St.**

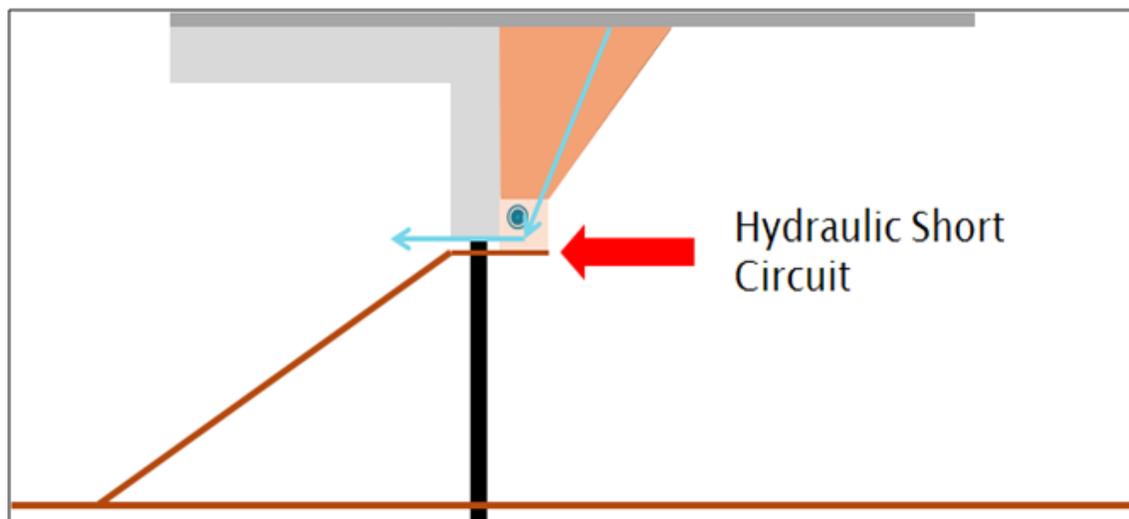
One of the most significant observations of this study is the amount of erosion occurring under abutments. This likely is contributing to significant loss of backfill and approach slab settlement. These observations led to a careful scrutiny of the backfill drainage design details for abutments, which resulted in an important finding. That is, basically some of the design details, such as those similar to the standard detail for integral abutment bridges in Figure 4.10, allow for a hydraulic short circuit to develop beneath the abutment. Thus, water in the backfill can largely bypass the drainage pipe and exit beneath the abutment causing large amounts of erosion over time. Figure 4.37 provides a schematic of the problem. The problem is that the proper function of the drainage system in Figure 4.10 requires that the contact between the bottom of the abutment and the underlying soil remains water tight so that water will be contained in the drain and exit via the pipe. Since the abutment is supported on piles it will generally not settle. However, any small amount of settlement of the soil beneath the abutment, which is highly likely in most cases, will cause a gap to open up and allow water to bypass the drain. Even if the embankment soil does not settle, it is unlikely that this contact is water tight and eventually water will begin to flow through this interface and cause erosion. Over time, extensive erosion can occur as observed at many sites.

**Figure 4.37 Schematic Cross-Section View of Hydraulic Short Circuit that Can Develop in the Abutment Drainage System**

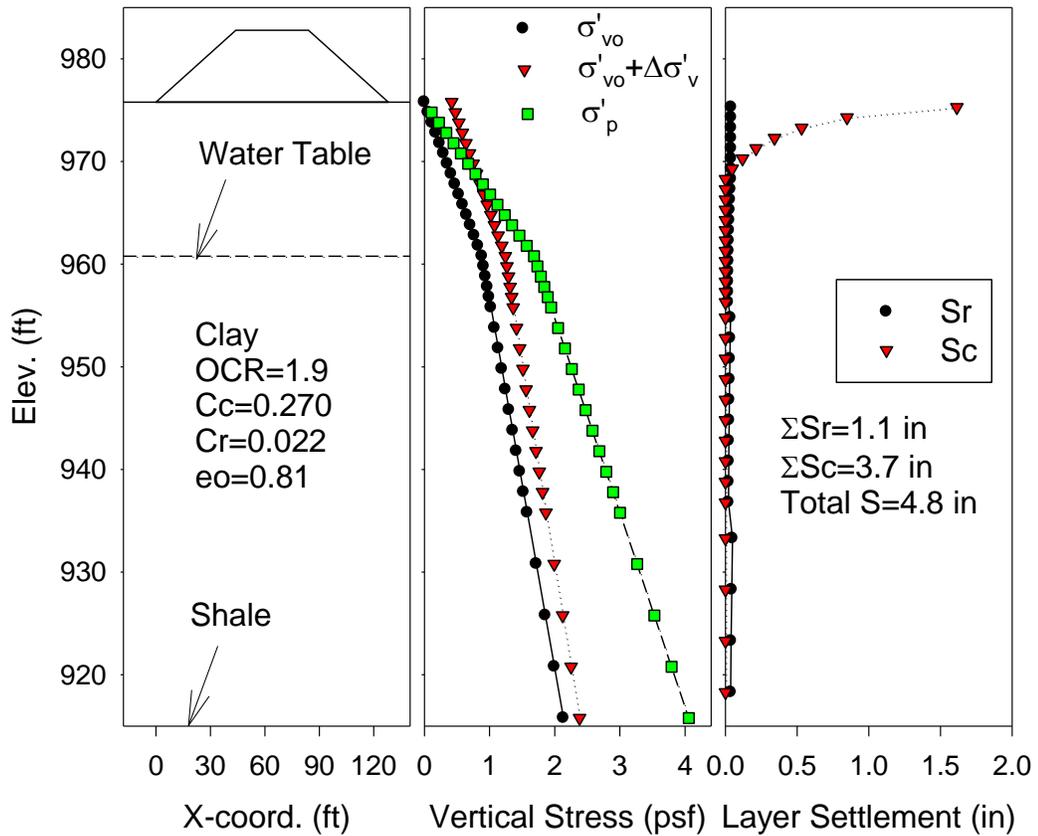
**Figure 5.8 Results of Settlement Analysis - SH-59A over Big Creek**

Settlement analysis based on the average results for parameters shown in Table 5.2 was conducted. Since oedometer data indicated relatively similar properties at different depths, a uniform clay layer with constant OCR was assumed. The embankment dimensions estimated from project plans and assumed stratigraphy are shown on Figure 5.7. Calculated total settlement based on average properties was 4.8 inches as shown in Figure 5.8, and consisted of 3.7 inches of virgin compression and 1.1 inches of recompression. Results of the settlement analysis shown in Figure 5.8 reveal that a significant amount (78%) of the total settlement is due to virgin compression while 22% is attributed to recompression in soil immediately beneath the embankment. This observation emphasizes the importance of having high quality estimates of settlement properties, especially preconsolidation stress, for soil immediately beneath the embankment where loading is the greatest. If a significant clay crust (weathered layer) had developed, expected settlements would be less. Using the range of settlement parameters in Table 5.2 gives a range of possible total settlements from 2.8 to 8.2 inches. Settlement predictions are consistent with the magnitude of observed settlements and are likely a primary cause of the approach slab settlement problem for SH-59A over Big Creek. In addition, as noted previously in this report, voids were observed under the slab indicating some erosion may also be contributing to the observed settlements.

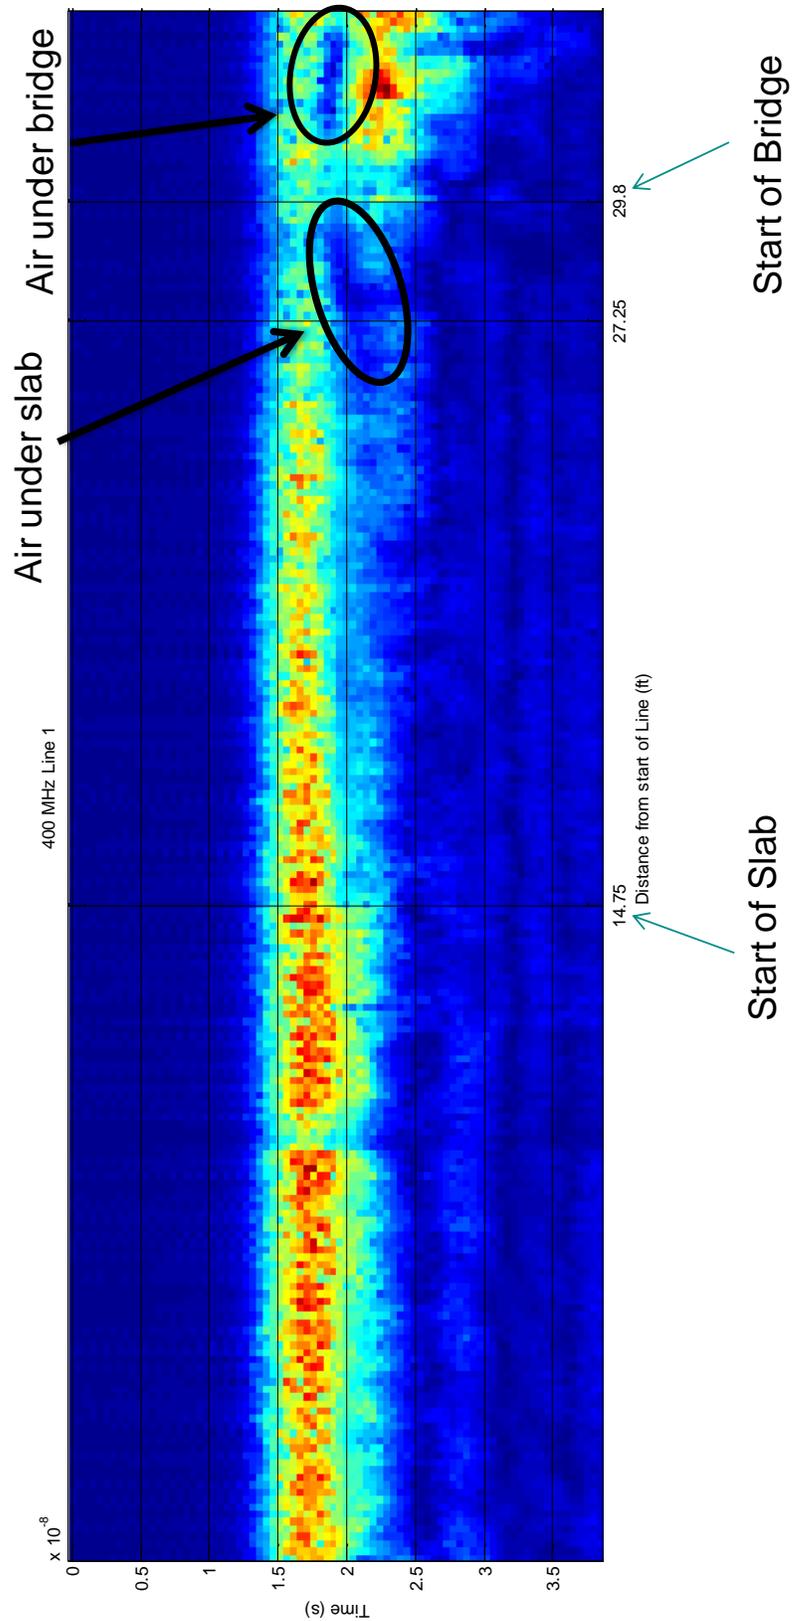
**Figure 5.10 Results and Interpretation of GPR Along a Line on the West Approach Slab in the Eastbound Lane – 400MHz Antenna**

In Figure 5.9 a photograph of the Portable GPR in use is shown. Figure 5.10 presents the results along one line of the GPR survey and interpretation based on the 400MHz data. Based on this initial work the following conclusions were made:

- Perturbation of waveform over void can be used for detection and approximate extent, but poor resolution.
- A higher frequency antenna (1-1.6GHz) is recommended for better resolution and characterization of the voids.
  - A large contrast between concrete and air as reflected on the 400MHz waveform should give a distinct reflection on higher frequency data.

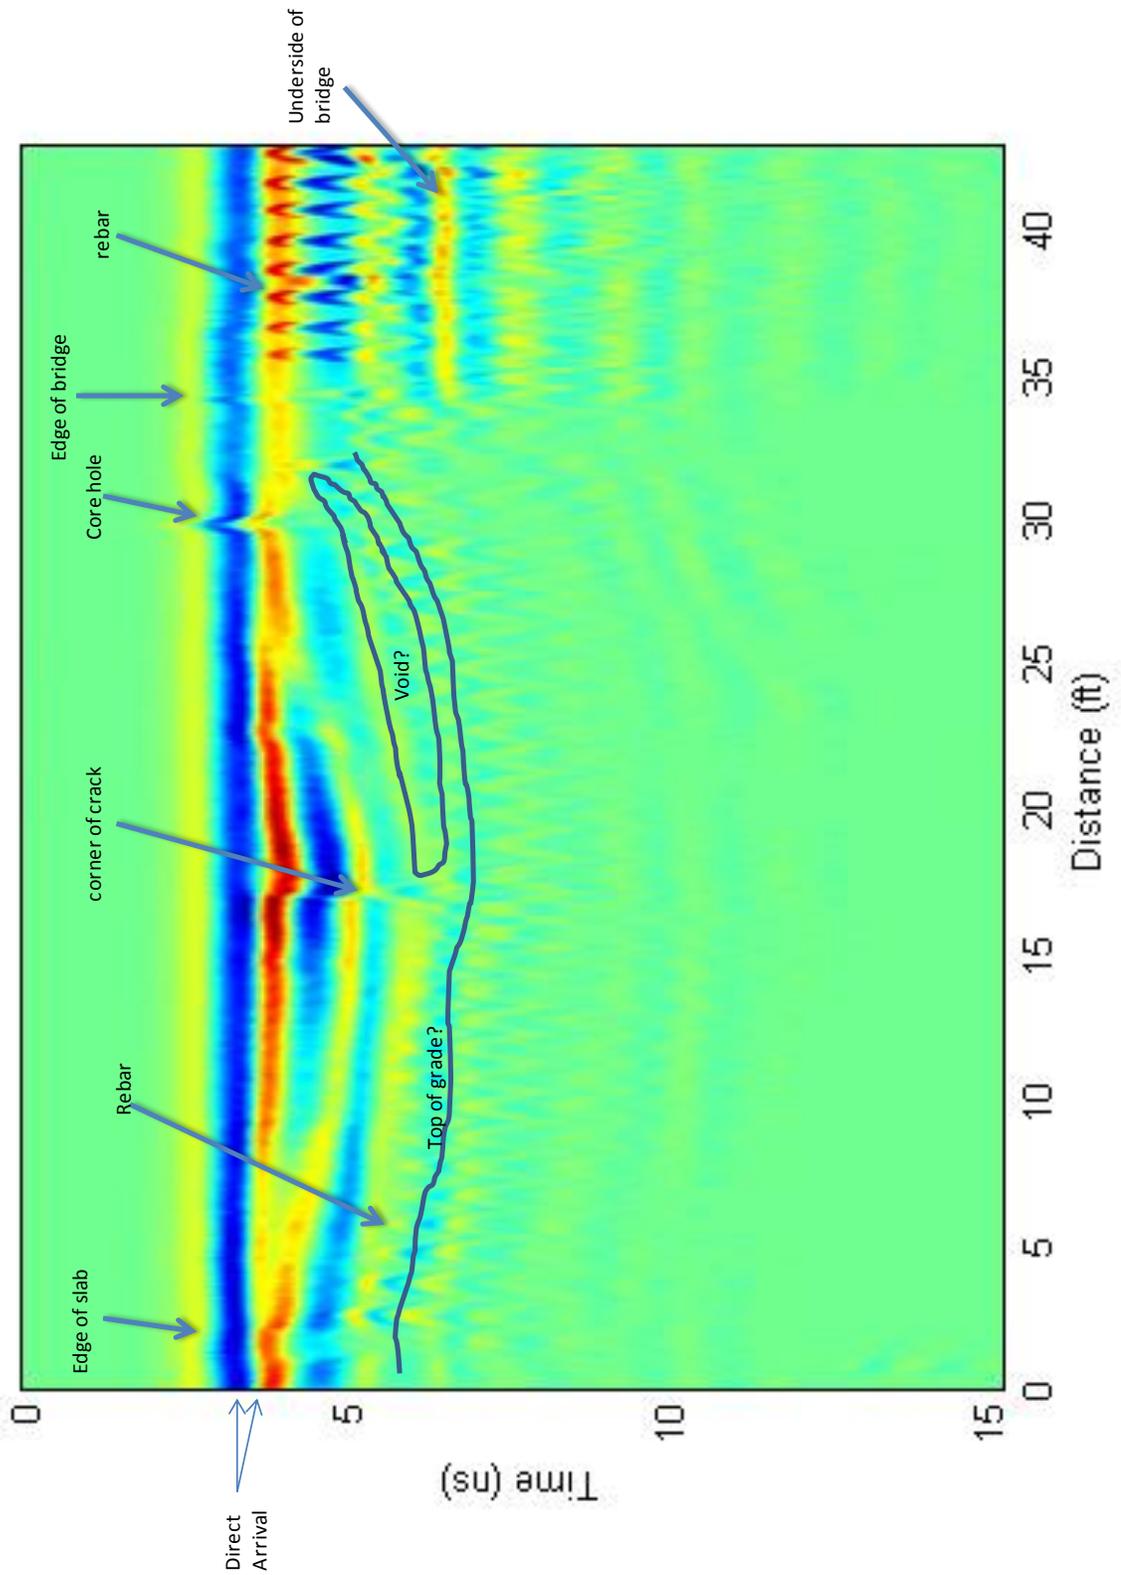
**Figure 5.11 Results and Interpretation of GPR Along a Line on the East Approach Slab in the Westbound Lane – 1.3 GHz Antenna**

Following the initial work using the 400MHz antenna, a 1.3 GHz antenna was obtained and used at the same site for comparison. While data interpretation is continuing, the preliminary results reveal stronger reflections from discontinuities in the pavement and greater potential for detecting voids. Results and interpretation from the higher frequency antenna are shown Figure 5.11. These preliminary results indicate the GPR may be a valuable tool for void detection under slabs, as well as other uses.

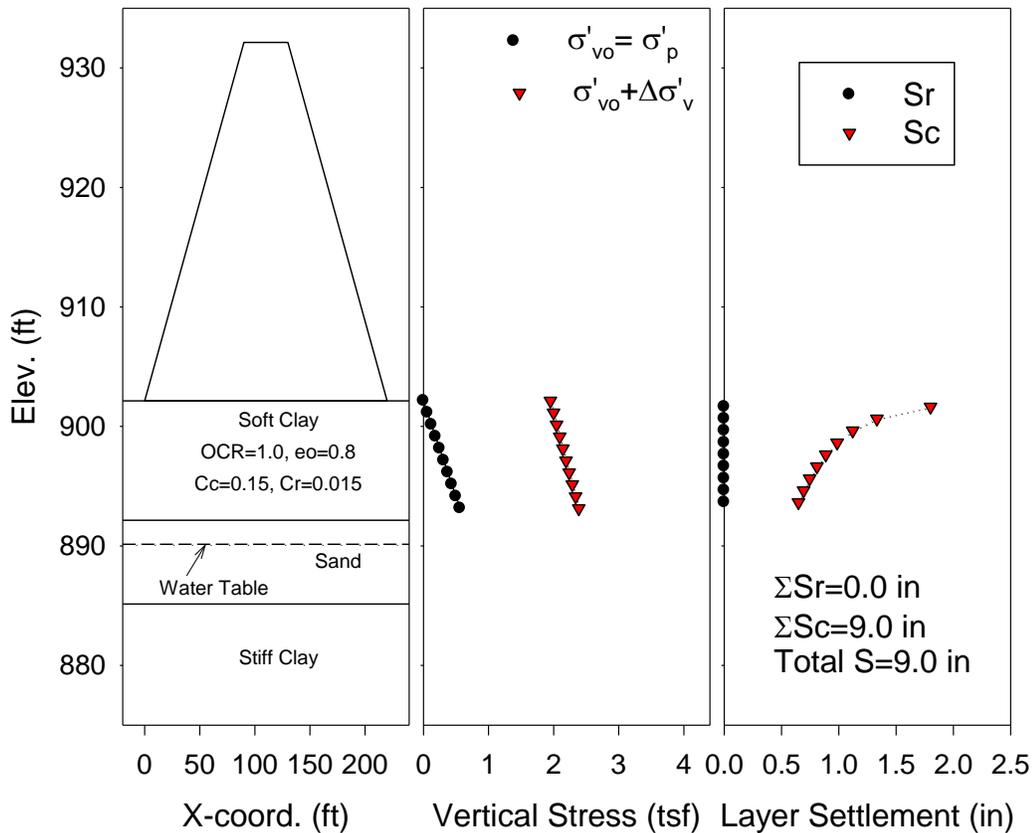
**Figure 5.19 Results of Settlement Analysis – US-177 over Salt Fork, South Embankment**

Two noteworthy observations from the subsurface investigation were the variability in the alluvial stratigraphy (CPT-6 vs. CPT-7) and the possible presence of a soft compressible clay layer below the fill (CPT-7). Settlement analysis considering only compression of the possible soft clay layer of 10-foot thickness was conducted based on oedometer results shown in Figure 5.17, and Table 5.4, and layer geometry shown in Figure 5.18. This layer was detected by the CPT testing; however, tube samples were not obtained from this soil since it was not encountered during drilling and sampling. Therefore, compression indices shown in Figure 5.19 are assumed values similar to those shown in Table 5.4. These are consistent with other Oklahoma soils as shown in Figures 5.5 and 5.6. Assuming the soft layer to be normally consolidated, predicted settlement using a modest virgin compression index of 0.15 is about 9 inches. It seems likely that compression of softer material beneath portions of the embankments has contributed to the observed settlement problem.

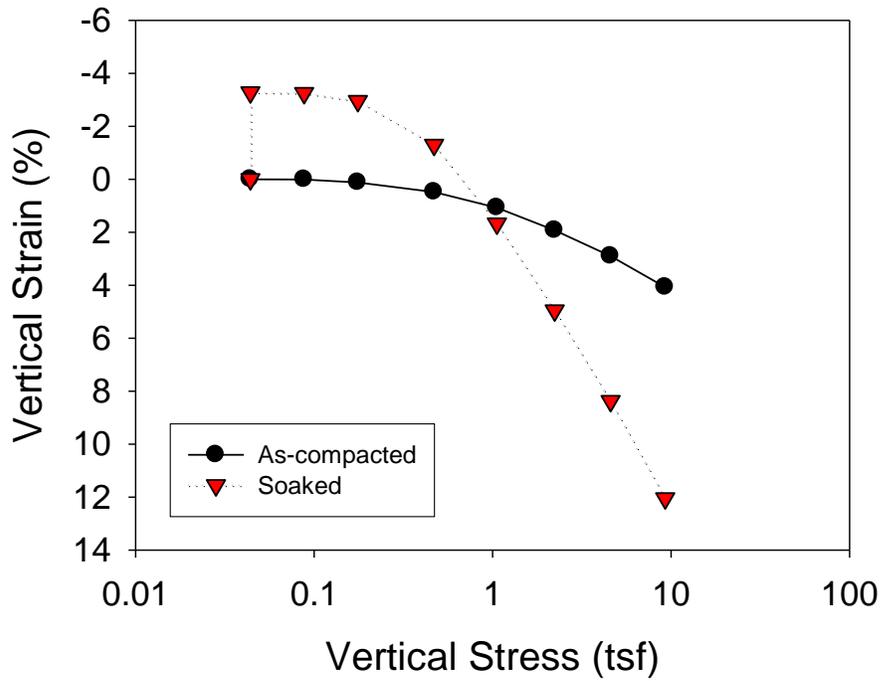
**Figure 5.20 Double-Oedometer Results – US-177 over Salt Fork: BH-1, 13-18 feet**

In addition to the settlement of foundation layers, compression of the fill material may have contributed to the overall settlement of the bridge approach slabs. Figure 5.20 shows double-oedometer data for a composite sample of embankment fill soil taken from 15 to 18 feet in Boring BH-1. Two samples were compacted to a relative compaction of approximately 97% and a moisture content 2 percentage points dry of optimum (approximate  $w=13.2\%$ ) based on the standard Proctor curve shown in Figure 5.21. This soil state is meant to represent the average compacted condition dry of optimum but within specifications. In Figure 5.20, the soil exhibits a significant tendency for swelling

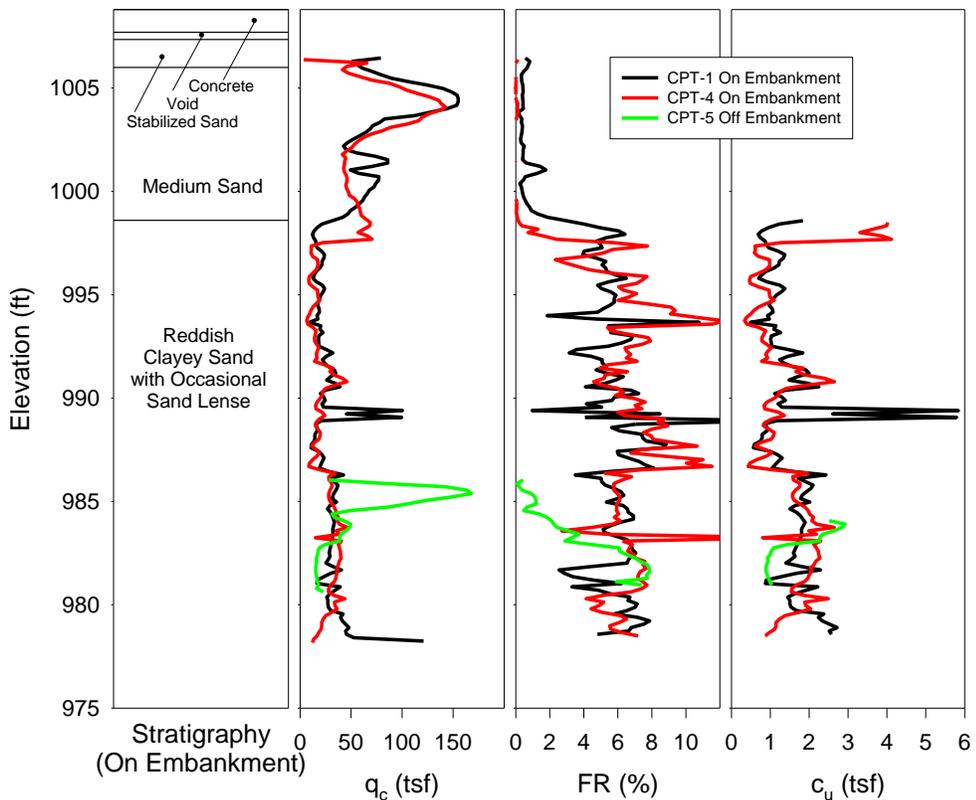
**Figure 5.37 Cone Soundings for East Embankment – SH-1 over SH-99**

Test boring and CPT sounding locations are shown in Figure 5.34. Soil properties and interpreted stratigraphy are presented in Figures 5.35 and 5.36 for the east and west embankments, respectively. Interpreted stratigraphy is based on results of test borings and CPT profiles shown in Figures 5.37 and 5.38. Based on the project drawings and subsurface profiles it appears the embankment soils consist of medium sand backfill behind the abutments and clayey sand for the remainder of fill. Based on project drawings it appears the embankment soils are about 10 feet thick on the west side and nearly 20 feet thick on the east side. Natural soils are quite variable below the west embankment and made up of clayey sand although weathered layers of sandstone, shale and limestone were encountered. Natural soils below the east embankment appear more uniform and consist of primarily of clayey sand. It appears based on the borings and CPT profiles for the east embankment that the natural soils are at least 13 feet thick. Results of CPT-1 show an increase in tip resistance at about 13 feet, which may indicate the beginning of the weathered rock zone. However, the CPT-4 sounding did not yet encounter rock at this depth as shown in Figure 5.37.

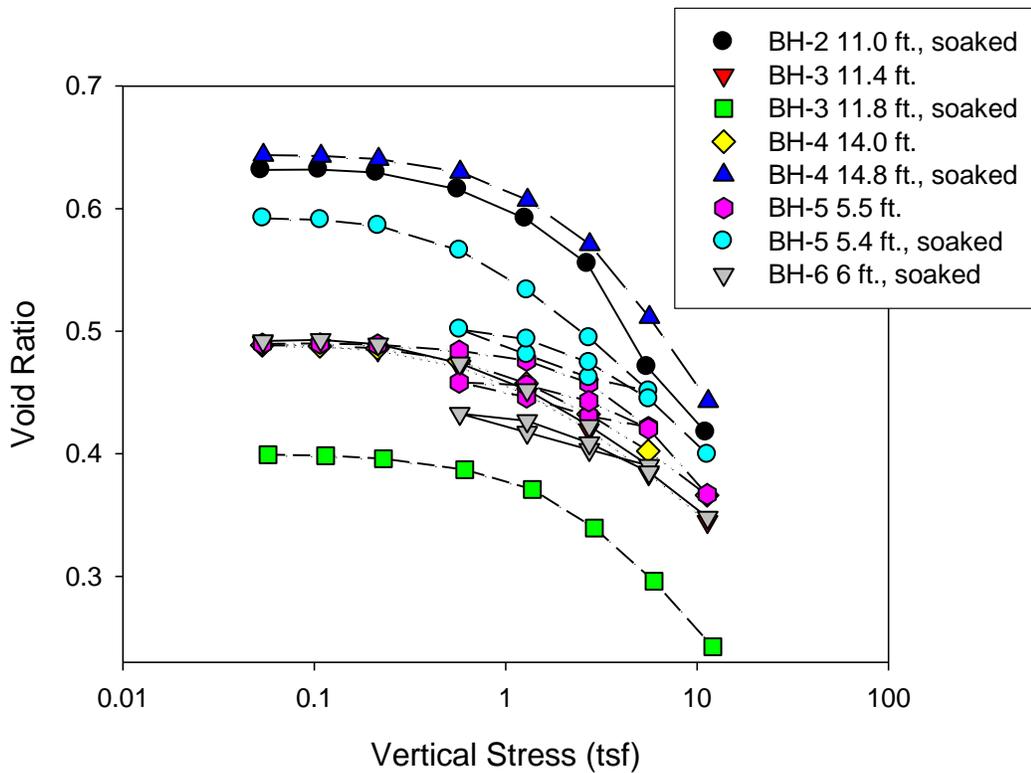
**Figure 5.39 Oedometer Test Results – SH-1 over SH-99**

Based on the preceding discussion, for the purpose of analyzing the settlement of the foundation soil a thickness of 15 feet was assumed below the east embankment. Consolidation test results are presented in Table 5.9 and Figure 5.39. The assumed embankment geometry and soil properties used in the analysis are shown in Figures 5.40 and Figures 5.41. Settlement parameters used for the analysis, shown in Figure 5.41, are based on the average values representing natural soils below the embankments corresponding to borings BH-4, BH-5, and BH-6 in Table 5.9. These parameters are consistent with other Oklahoma soils as shown in Figures 5.5 and 5.6, although recompression parameters for the higher PI soils are higher than noted for other sites. It should be noted the higher recompression indices were obtained from unload-reload curves for these particular higher PI soils.
